Flamanville 3 EPR

Safety assessment and on-site inspections

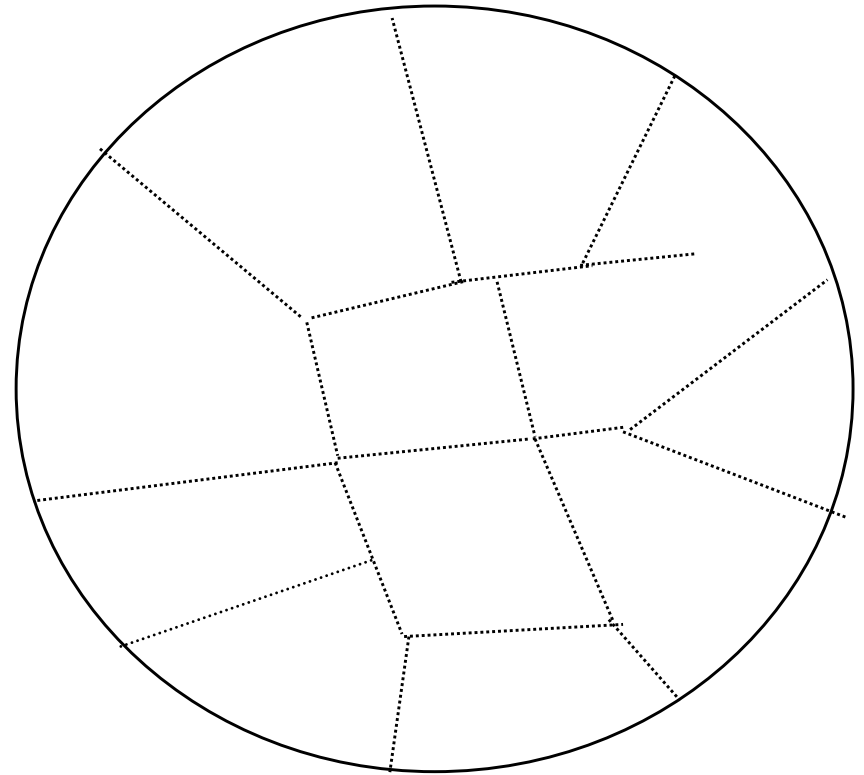
- December 2007: concreting for first time of common basemat on nuclear island under the reactor building (4225 m³, thickness 1.8 m)
- Several days later: open cracks of 1 mm to 3 mm
- After cooling: open cracks of 0.4 mm to 1 mm
- Repair: injection of cracks

Configuration of cracks in the circular basemat

- Cause of this non-conformity:
 - thermal effect due to the heat of hydration of the cement during concrete setting (expansion and contraction due to exothermic reaction)
- Aggravating circumstance:
 - lack of reinforcement mesh in the upper part of the lift
- Risk:
 - reduced durability of the structure;
 - possible corrosion of the bottom reinforcement even if cracks are grouted;
 - presence of water below the basemat should be detected during the lifetime of the plant.

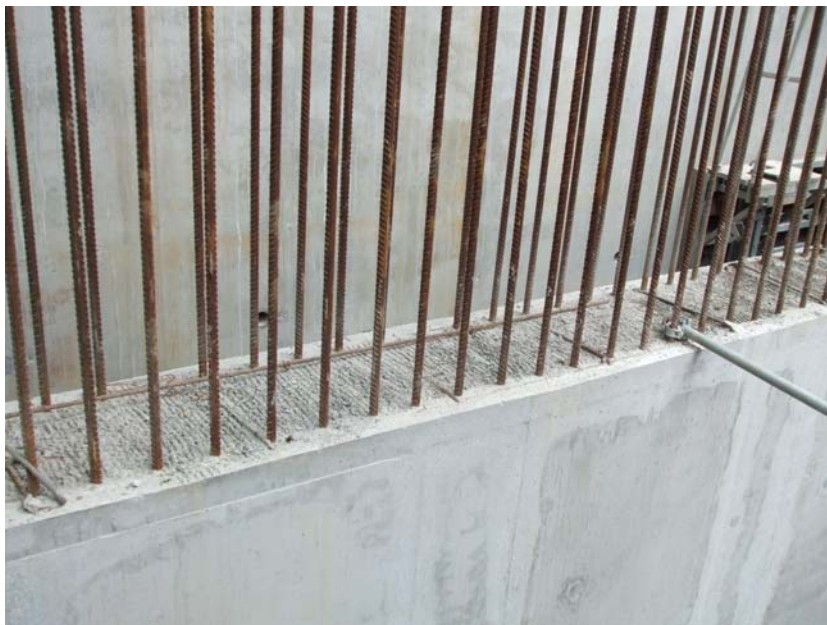
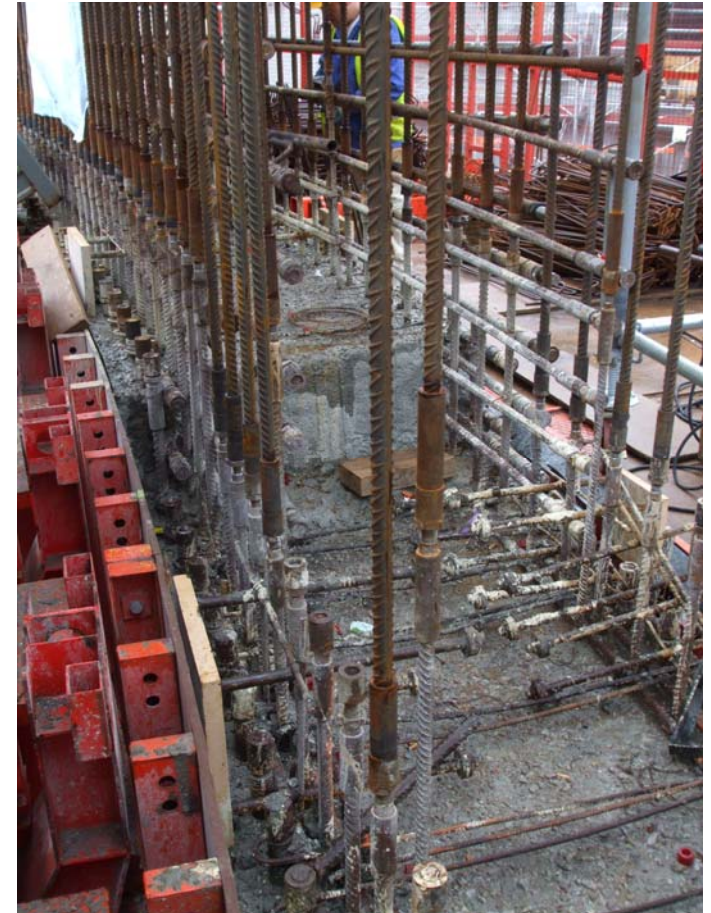
- Site practice seen during 4 inspections
 - Gusset -6.25 m : no treatment
 - Rake
 - Deactivator

Examples of concreting joints

- IRSN Technical assessment >> ASN letter sent to EDF
- An unsatisfactory treatment of construction joints can lead to lower quality joints which jeopardize construction quality:
 - Robustness of structures;
 - Durability (faster than expected steel reinforcement corrosion).
- Structures are not conform to design hypothesis: design margins and expected lifetime can be lower than previewed.
- IRSN asks dedicated structural verifications, taking into account awkward joints treatments.

- EDF actions :
 - stopped using one of the « deactivators »;
 - undertaken a dedicated test program;
 - strengthened its survey in that field.
