Potential Risk of a Criticality Event During Refuelling

V. Laurieux, P.Deschamps.

Radiological Protection and Nuclear Safety French Institute (IRSN),

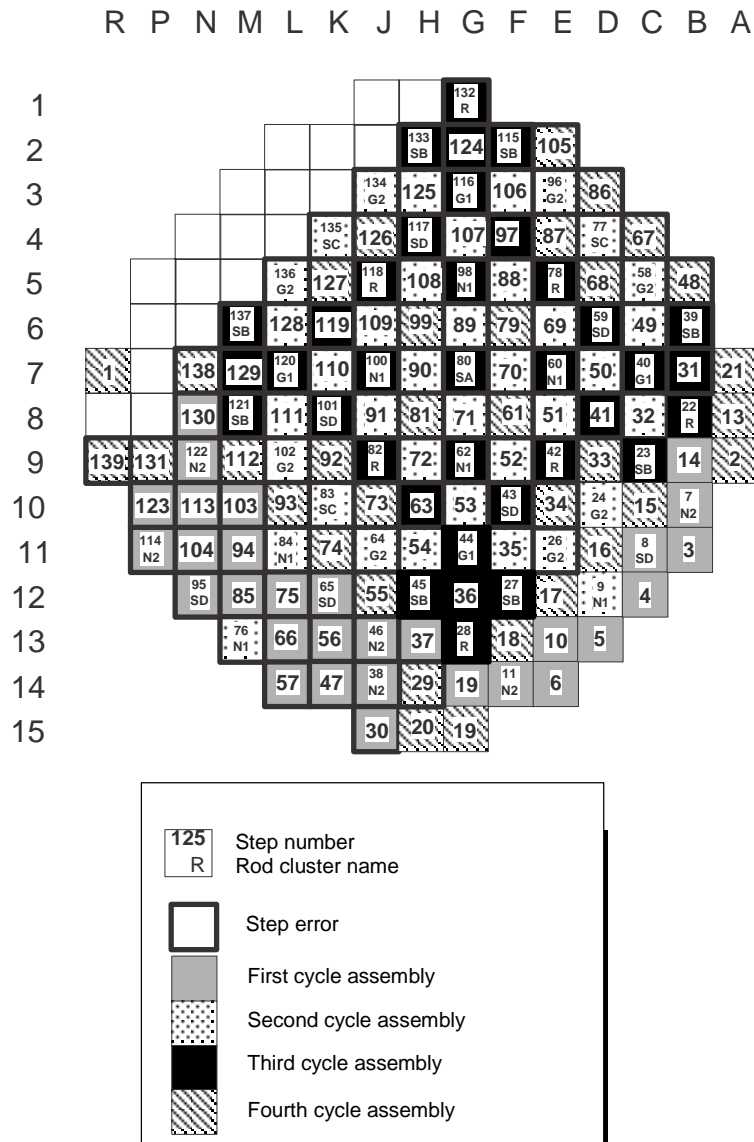
Dampierre Unit 4 Campaign 18 : Core Configuration with handling error

Loading the assembly of step n° 26 in the core in the position of the assembly of step no. 25 led to 113 assemblies being loaded in a wrong position, resulting in an unusual core configuration. A large number of 1st cycle fuel assemblies were loaded in the lower left-hand quadrant as shown below. As a consequence of this core configuration, several 1st cycle assembly patterns (burn-up = 2 GWj/tU) were formed, locally helping to reduce the margin to criticality.

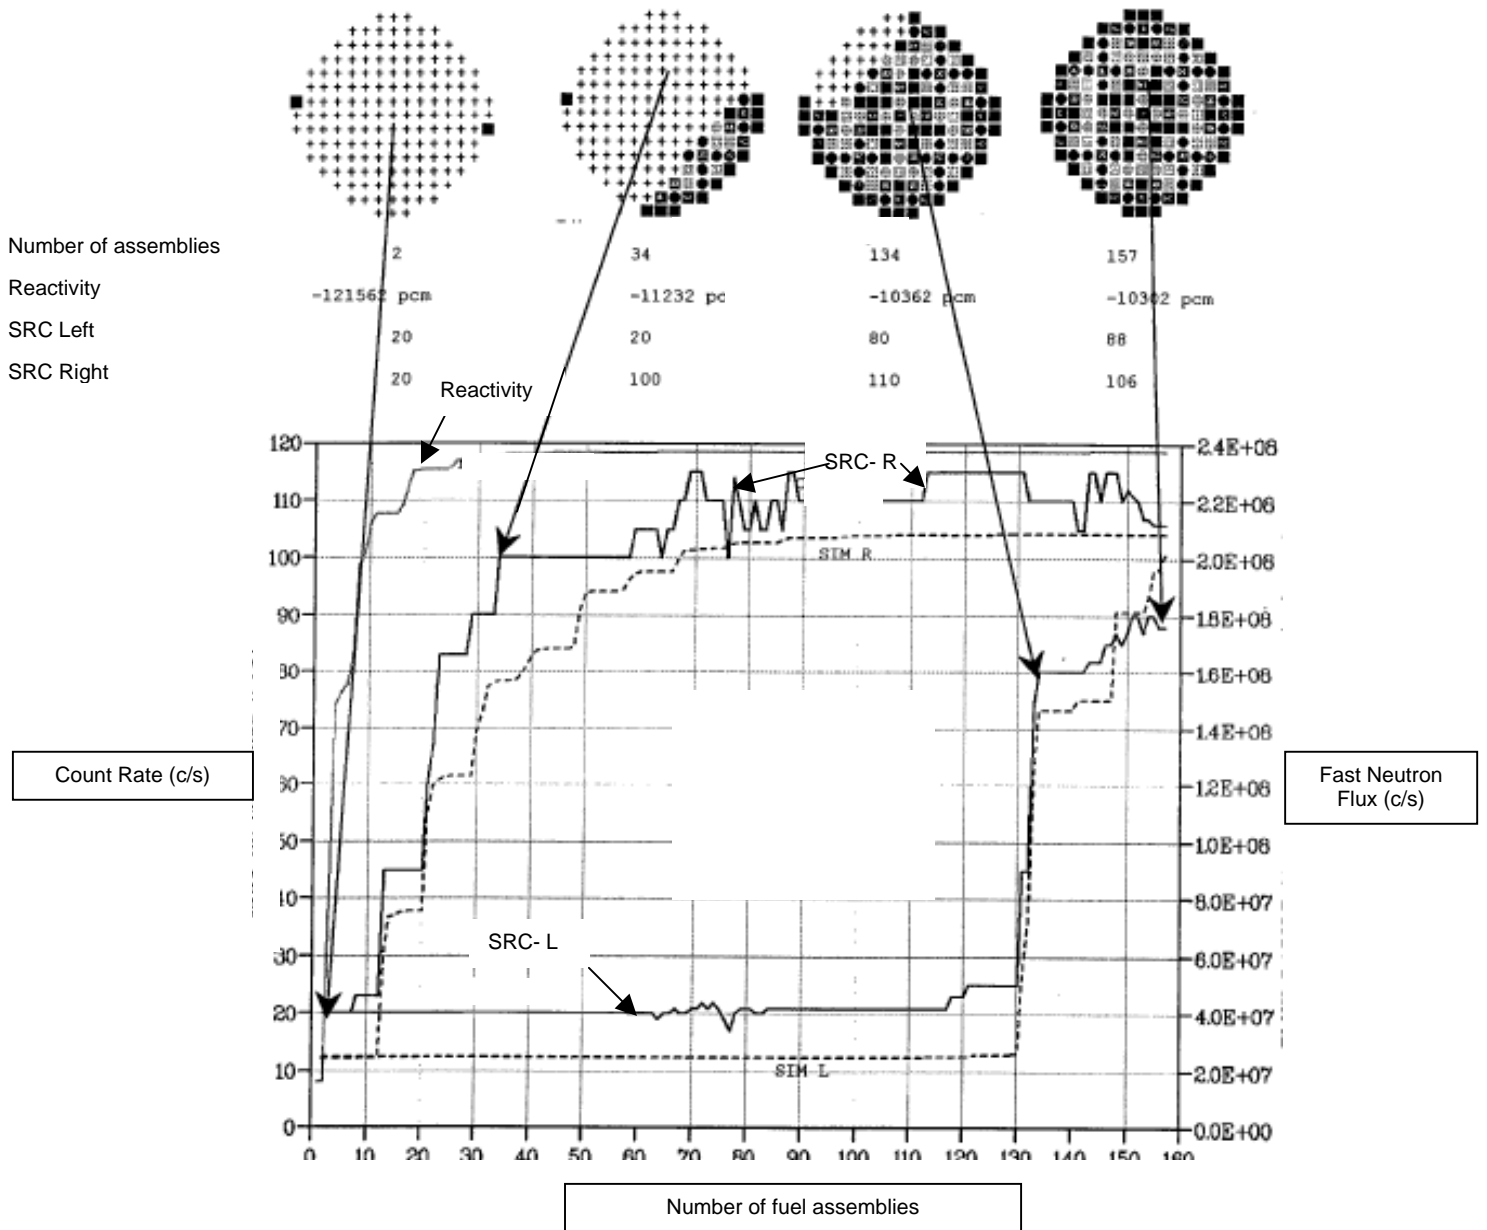
Tricastin Unit 3 Campaign 19 : Comparative evolution of the SRCs count rates (SRC-L ; SRC-R) and of the simulations (SIM L and R) - Reactivity evolution along the refuelling

One can notice that along the refuelling, the SRC-L count rate has firstly been only under the influence of the first fuel assembly loaded, located on the R7 isolated position and this, until the introduction, at steps n° 131 and n°133, of the fuel assemblies on R8 and R9 locations close to SRC-L.

As the refuelling progresses from the south east side of the core towards the north west side, the SRC right indicates a significant evolution only in case a fuel assembly is loaded near this detector.

Furthermore, this figures allows to draw the conclusion that the increases of the SRC count rates and the reactivity increase are not correlated.

Moreover, it appears that the calculations can be considered as an indicator able to evaluate the global SRCs count rate evolutions.

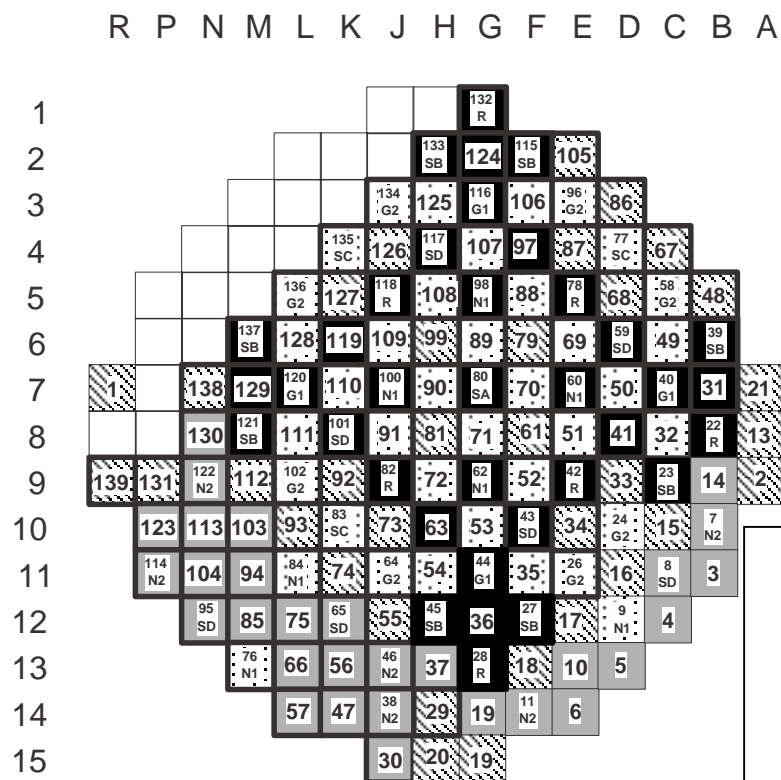
Core loading pattern due to the erroneous refuelling on Dampierre Unit 4 Campaign 18

The fuel element of step n° 26 was loaded in the reactor vessel in position E11, that the element of step n° 25 should have occupied. As a result, this step error was passed on throughout the refuelling procedure, until the 138th fuel assembly loading (step n° 139).

At step n° 139, the RB refuelling machine operator noticed that the distribution of rod cluster assemblies in the core under refuelling was not in accordance with the symmetrical pattern expected. At that time, the refuelling operations were stopped.

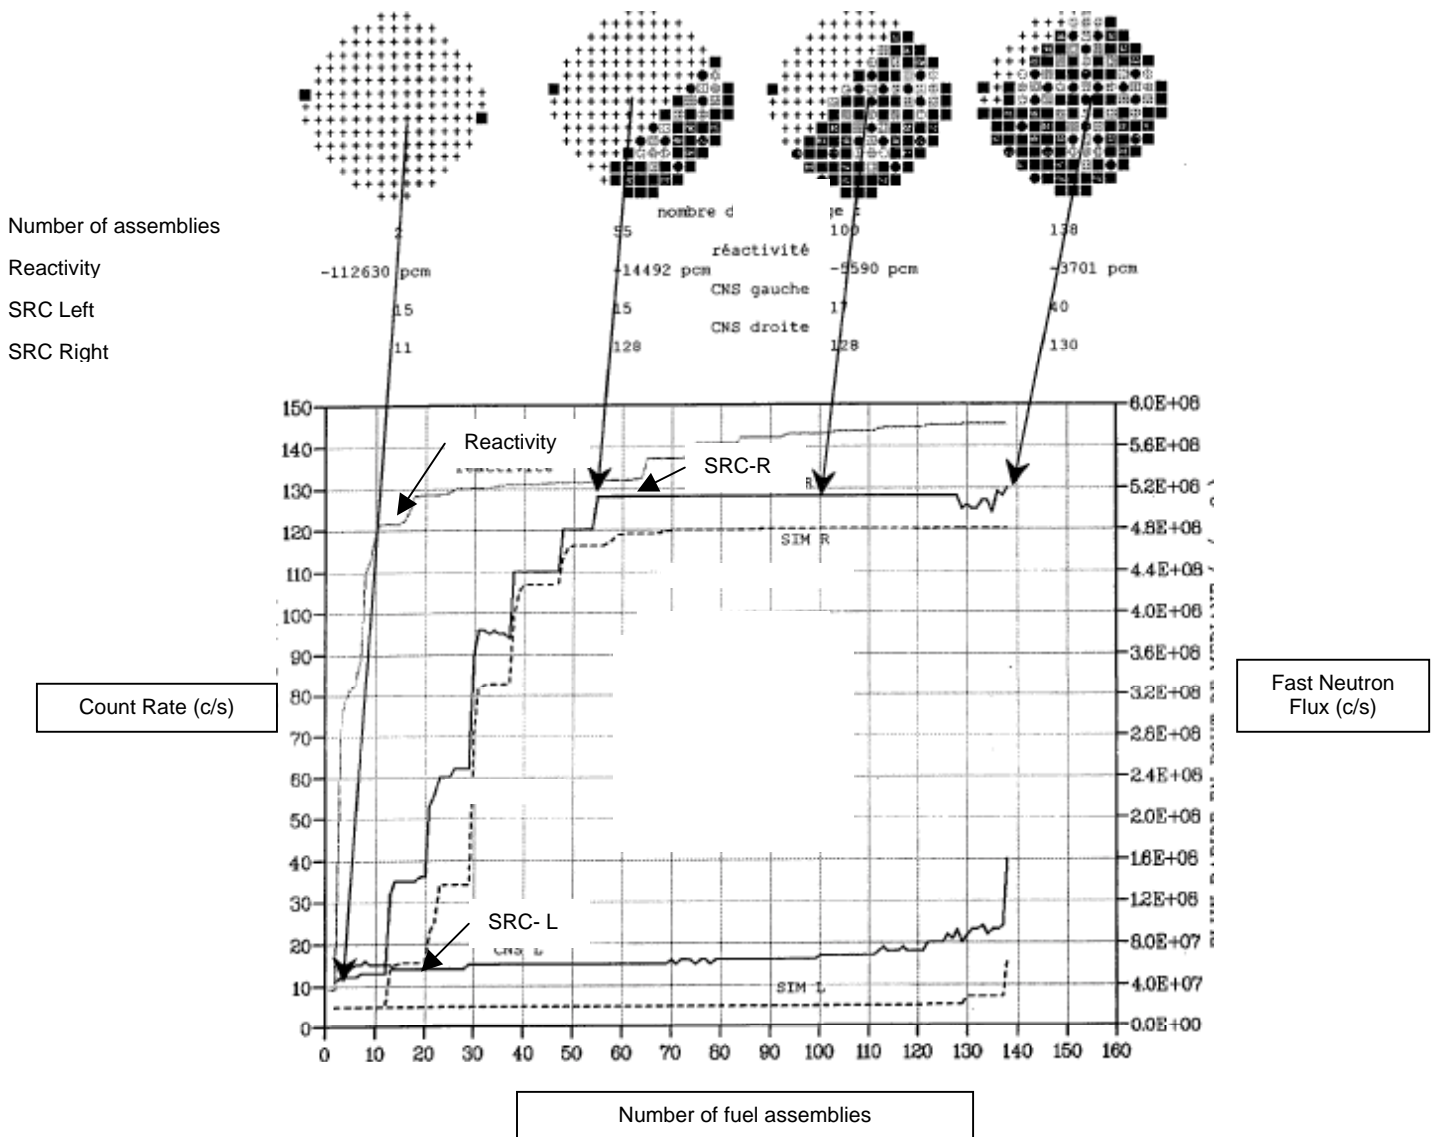
Erroneous refuelling on Dampierre Unit 4 Campaign 18 : Comparative evolution of the SRCs count rates (SRC-L ; SRC-R) and of the simulations (SIM L and R) - Reactivity evolution along the refuelling

As the graph above shows, the evolution of the count rates of SRC-R and SRC-L along the incidental refuelling of Dampierre Unit 4 have not been influenced whereas the reactive group of fuel assemblies was in progress, between steps n° 60 and 130. As observed for the normal refuelling on Tricastin Unit 3 campaign 19, the SRC count rates have only been significantly increased at the time when the irradiated fuel assemblies were introduced near the detectors. As a matter of fact, the count rate generated by the SRC-R has been sharply increased at step n° 30, from a value of 62 to 90, because of the loading of a MOX irradiated fuel assembly instead of a 1st cycle UO₂ assembly due to the loading error at step n°25. However, this abnormal evolution is not significant enough to detect a handling error, since similar changes in count rate evolutions have been observed independently from that type of incident.

Concerning the SRC-L, the most significant increase is connected with the introduction of the second fuel assembly in the vicinity, namely step n°139 in R9 position.

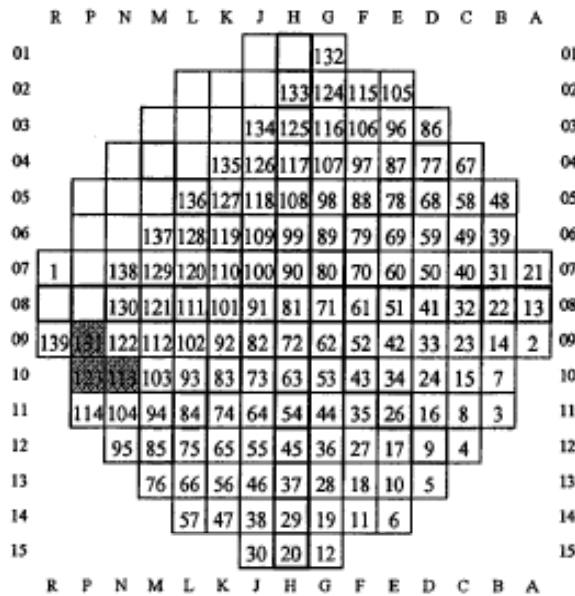
Comparative evolution of the SRC responses

As shown on the figure below, the step n°25 has been omitted to restore the Dampierre Unit 4 conditions.

Simulation of the divergence occurrence successively on 3 steps : 113,123 and 131

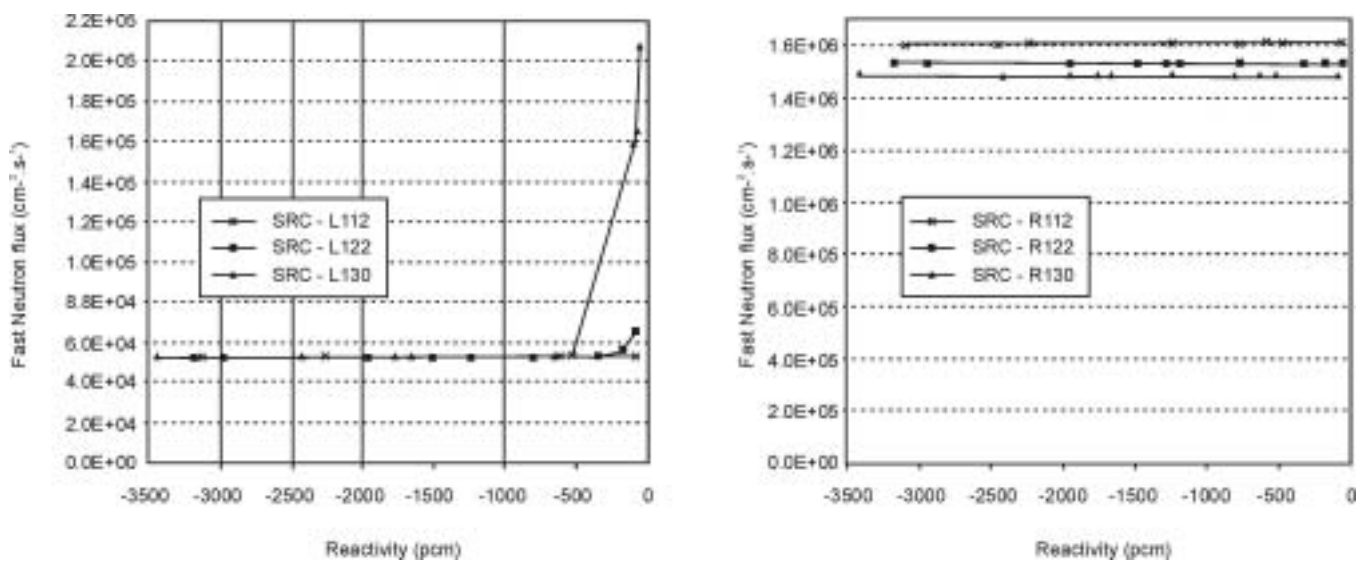
As the previous graph shows, it is noticeable that the indications of SRC-R, which is the farthest from the reactive group, remain unchanged wherever the location of the divergence takes place and whatever the core reactivity level reached. Concerning the SRC-L, a slight increase in count rate occurs at the time of divergence on fuel assembly n°122, following by a significant increase when loading fuel assembly n°130, which indicates that the ability of the SRC to detect the divergence, as it approaches, is depending on the distance between the SRC and the location of the reactive group.

Furthermore, it is noticeable that the sharp increase in the SRC-L count rate when loading the fuel assembly n°130 is responsible for the alarm actuation, and thus the detection of the divergence, independently of the value effectively reached by the SRC-L count rate : actually when the divergence occurs, at step n° 130, the SRC-L count rate remains under the SRC-R count rate value, and below the count rate reached at the end of a normal refuelling. During the refuelling, the alarm liable to be actuated is the “high flux on shutdown” alarm, set to three times the flux on the previous count on the SRC concerned.
