Lessons Learnt from the Resin Release into the Primary Circuit of the Fessenheim NPP Unit 1 in January 2004 – Impact on the Nuclear Safety

Mioara Georgescu (IRSN)

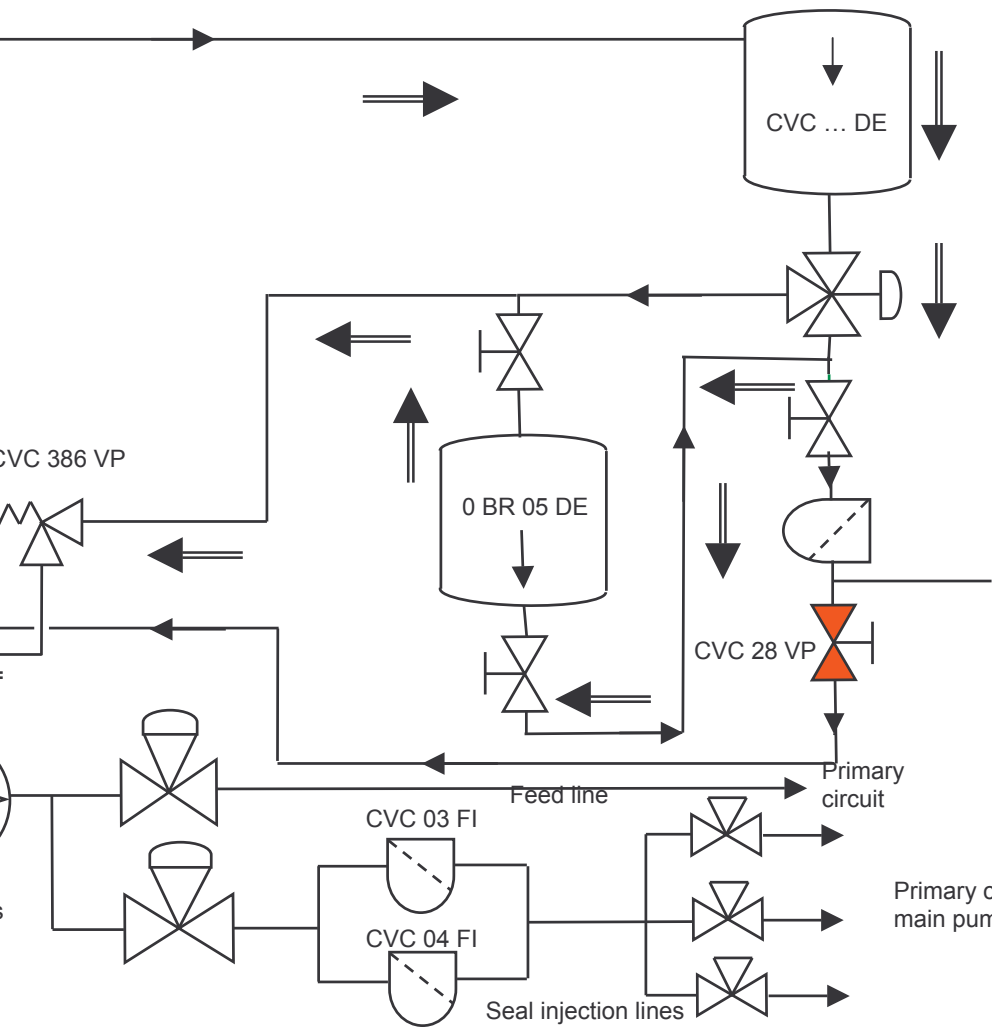
Figure 1. Simplified Flow Sheet

Due to lack of preparation, a human error was committed in the demineralizer line-up to flush it out. As the valve 1CVC28VP was closed, the primary circuit bleed flow was interrupted downstream the demineralizer, causing the bleed line and the demineralizer pressurization.

The demineralizer safety valve 1CVC386VP opened, creating an unexpected flow through the demineralizer, from its bottom to the top. In such a configuration, there is nothing to prevent resins release from the demineralizer. As the outlet of this safety valve is connected to the CVC head-tank, resin particles (smaller than 1 mm diameter) were discharged into the CVC head-tank and thereafter the running primary circuit feed pump sucked them in and sent them into the primary circuit.

The IRSN emphasized the necessity to adjust this error as soon as possible. EDF central services are studying a design solution capable to prevent such an incident to be repeated. Waiting for the design change accomplishment, the isolating valves of the BR demineralizers have been physically locked out.

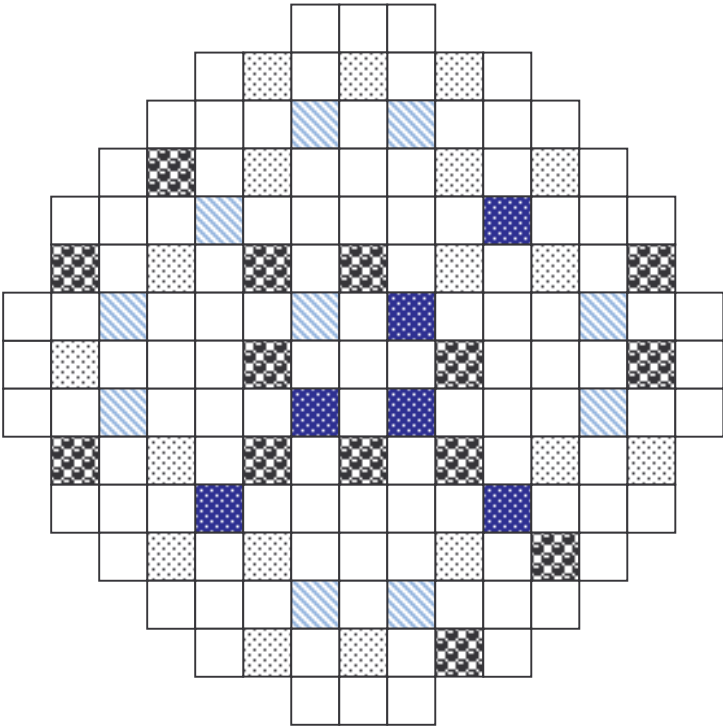
a) on February the 13th

- ✓ *20-out-of-48 rods failed to drop from the fifth step (Figure 2a) during a test carried out on February the 13th (while the unit was in cold shutdown state).*

The rods jamming into the neck section of the guide tubes was explained by the clogging of the interspaces between the rods and their guide tubes (0.2 mm) during the seven-day period preceding the test, when 32-out-of-48 rods were held inserted at the fifth step. The other 16 rods, inserted at the fifth step just before the test, dropped correctly. The rods drop test was repeated the same day, this time from the 16th step and all the rods dropped correctly, as the guide tubes were well enough cleaned during the rods extraction to make it possible.

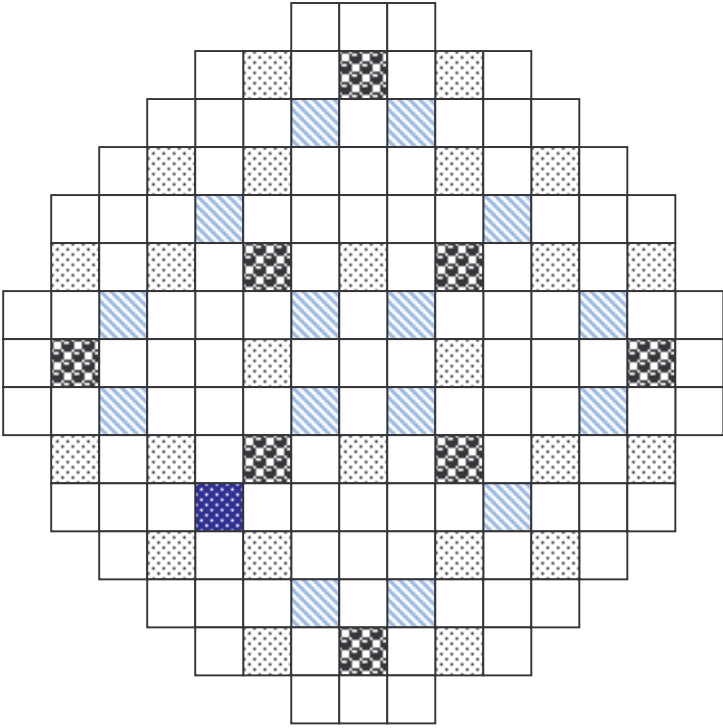
b) on June the 18th

It has to be noted that a similarly event occurred on June the 18th during the unit start-up tests. Few hours after the start-up of the primary circuit main pumps, while the unit was in cold shutdown state, the operator attempted to align the rods (found in different positions between the fifth and the seventh step) by opening the reactor scram breakers. 9-out-of-48 rods failed to drop (Figure 2b). The rod jamming was explained by the clogging of the interspaces between the rods and their guide tubes due to a "relocation effect" of the resin residue caused by the start-up of the primary circuit main pumps. This resin residue created friction, that did not allow the rods to drop.

Following the event occurred on June the 18th, when 9 rods failed to drop from different positions between the fifth and the seventh step, special attention was given to the reactor scram function availability. The IRSN considered that several types of rod drop tests were necessary to be carried out: in cold shutdown state, after the restarting of the primary circuit main pumps (in order to reproduce the conditions of June the 18th) and also in hot shutdown state, with the control rods in different positions and the shut off rods held extracted from the core over various time intervals (in order to reproduce the full power operating conditions). No deviations were detected.

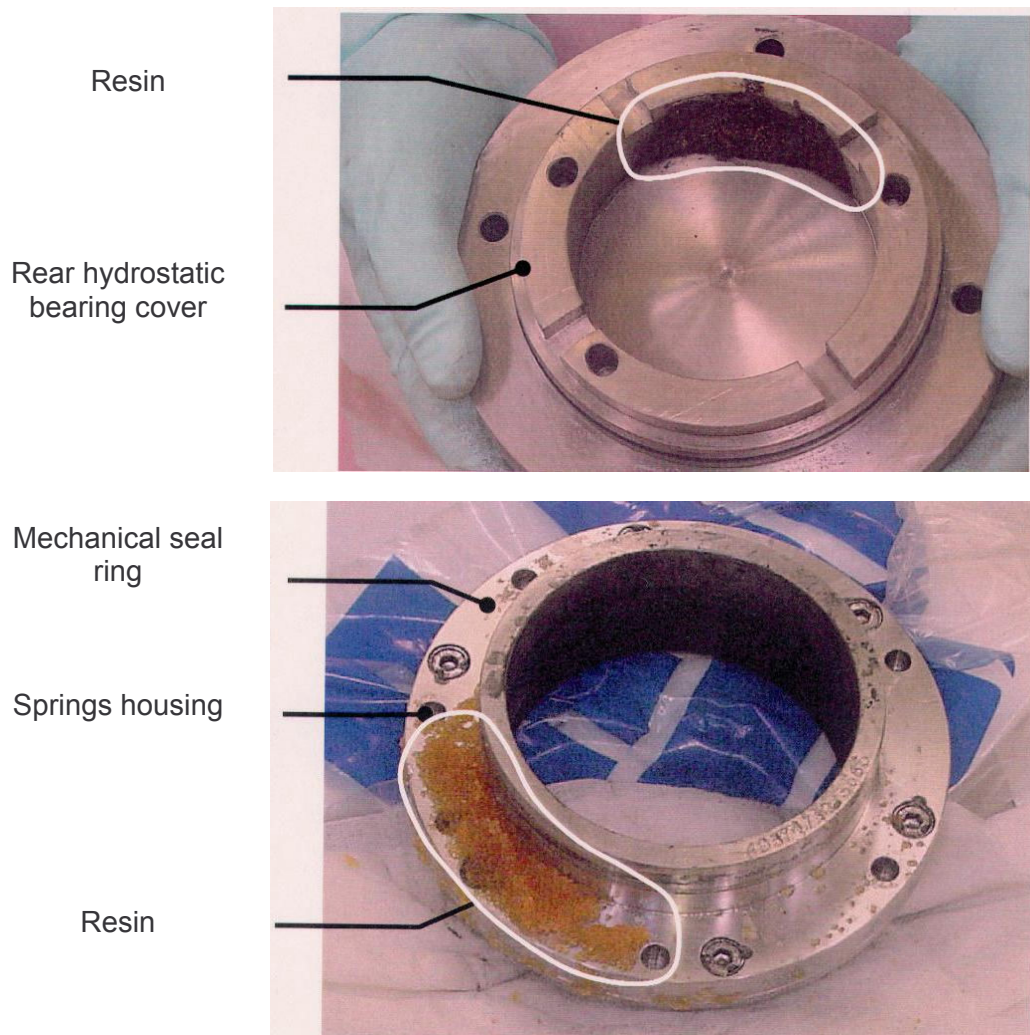
Figure 3. Rear hydrostatic bearing and mechanic seal of the pump CVC02PO

- ✓ *The shaft of the running primary circuit feed pump CVC02PO (Figure 3) was found seized into the rear hydrostatic bearing following the pump stop. The operator found one-out-of-five supplying diaphragms of the rear hydrostatic bearing blocked, probably causing a pressure decrease under a required value, necessary to correctly sustain the running pump shaft. The friction between the rotor and the stator quickly worn their protective coating made of stellite and overheated the assembly. As the pump was stopped following a routine operation on February the 3rd (while the unit was in hot shutdown state) and kept in stand-by thereafter, the rotor and the stator welded together causing the pump failure to start on March the 1st (after the fuel unloading). The pump expertise revealed, besides a resin amount inside the pump components, a 0.2 mm shaft growth on its side nearby the rear hydrostatic bearing and the three adjacent impellers. A quantity of metal turnings produced by the protective coating wearing was found in the bearing and in each of the impellers of the pump discharge stage.*

The three primary circuit feed pumps also ensure the high pressure safety injection function. On February the 3rd, the pump CVC02PO, running during the incident, was stopped and the stand-by pump CVC01PO was started (routine operation usually made each 15 days). On March the 1st, the pump CVC02PO failed to start and its shaft was found welded into the rear hydrostatic bearing (the same day, the pump CVC01PO, stopped after the fuel unloading, started successfully).

- ✓ affected equipment restoration or replacement (the primary circuit feed pump CVC02PO and the rotor of the primary circuit main pump 2 were replaced),
- ✓ resin residue removal (as much as possible) and potentially affected components inspection (fuel assemblies, rods, pumps, sensors, heat exchangers, tanks, valves, pipes),
- ✓ design changes accomplishment (installation of nuclear sampling suction filters, removal of thimble plug assemblies),
- ✓ potential confined areas flushing out (thermal barriers of the primary circuit main pumps, pressure vessel bottom penetrations and in-core instrumentation guide tubes).

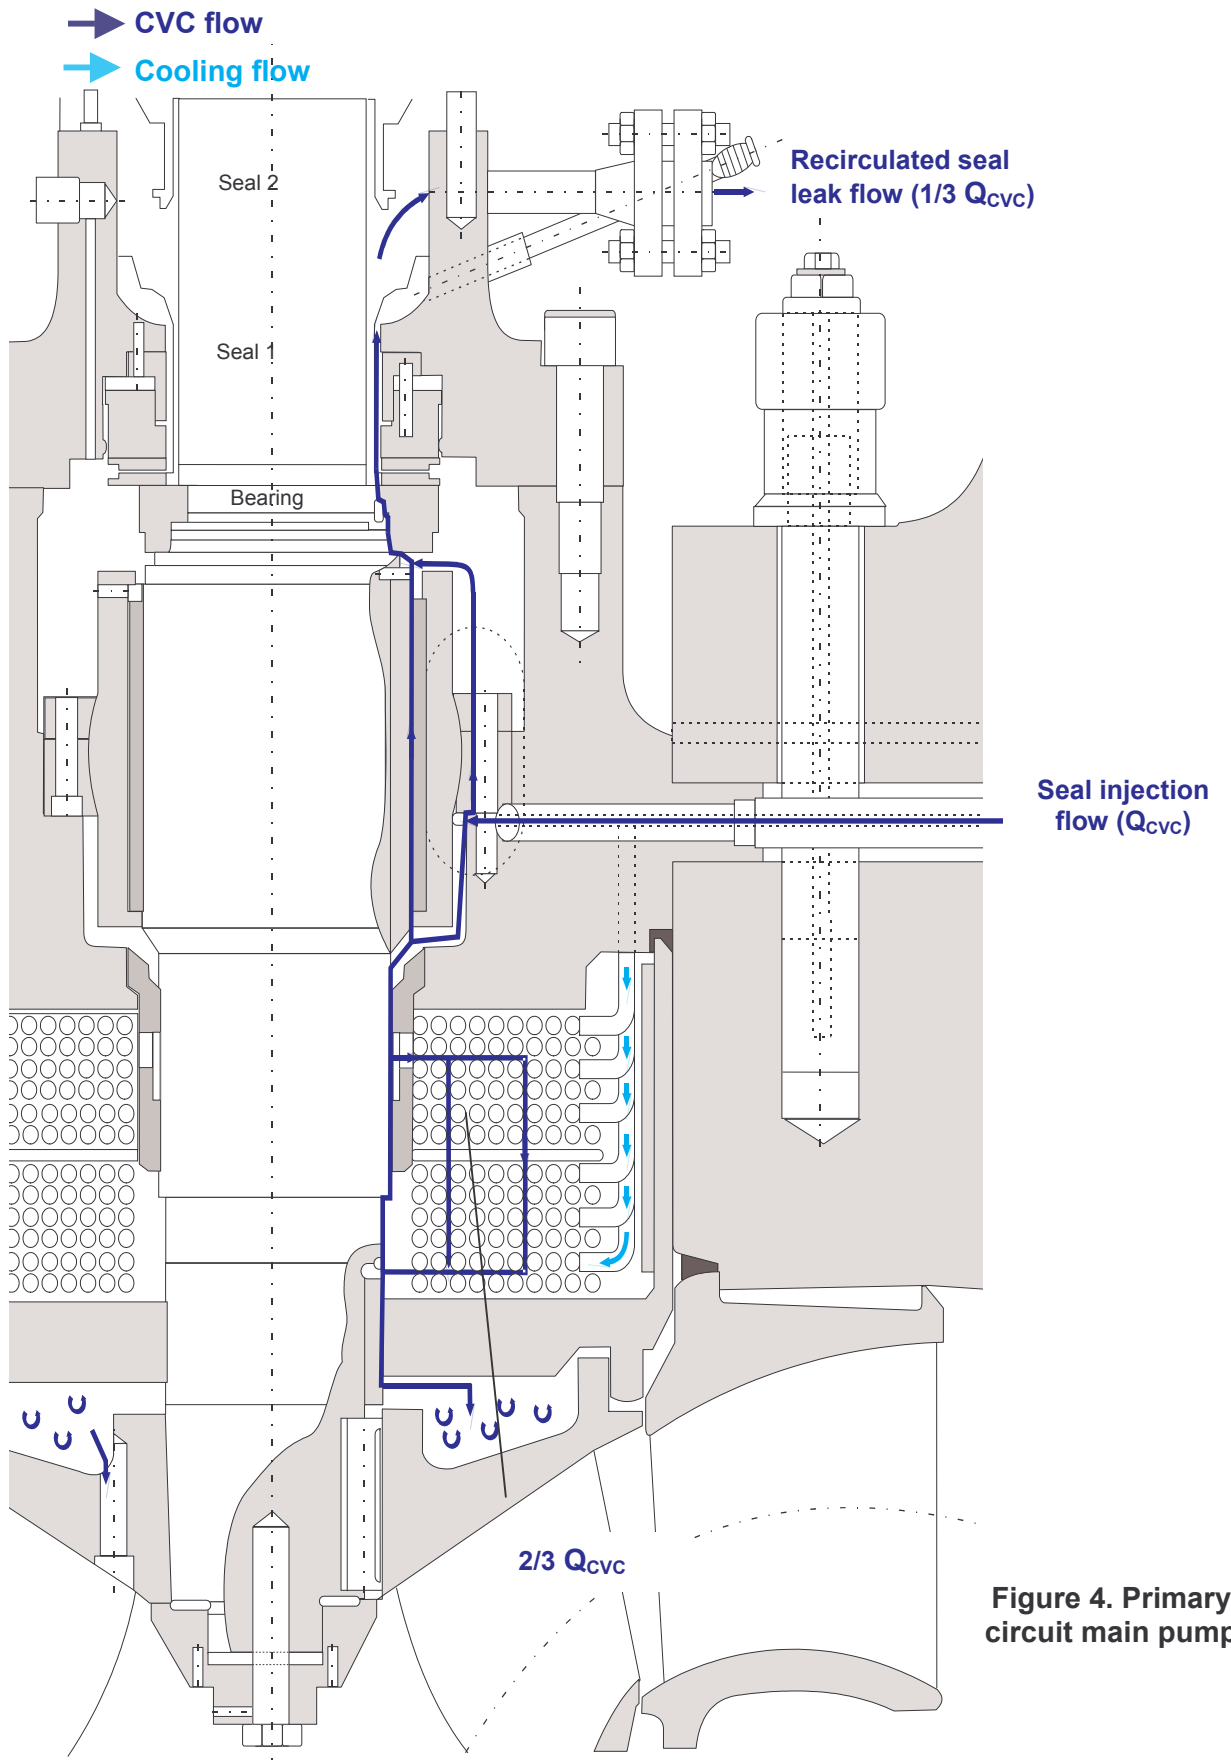
Figure 4. Primary circuit main pump

- ✓ *Resin was found in the seals and bearings of the primary circuit main pumps. As the filters on the seal injection lines were clogged, non-filtered water from the primary circuit was injected into the main pump thermal barriers, after passing through the upper and the lower cooling labyrinths of these thermal barriers*

(interspace: 0.5 to 0.7 mm), the bearing and the seal 1, before being evacuated via the recirculated seal leak line (downstream the seal 1, Figure 4).

Immediately after the incident, the rate of the recirculated seal leak flow (downstream the seal 1) of the primary circuit main pump 2 began to increase. On January the 28th (while the unit was in hot shutdown state), the pump tripped as the rate of the recirculated seal leak flow increased up to the automatic trip set point. The pump seal dysfunction is probably the resin presence consequence.

For this reason, the IRSN recommended the replacement of the thermal barriers of these two pumps or at least their expertise during the next unit shutdown.
