IRSN ASSESSMENT OF FUEL RODS FAILURES DUE TO FRETTING PHENOMENON CYCLE 8 OF CATTENOM 3 UNIT

(A. Halter)

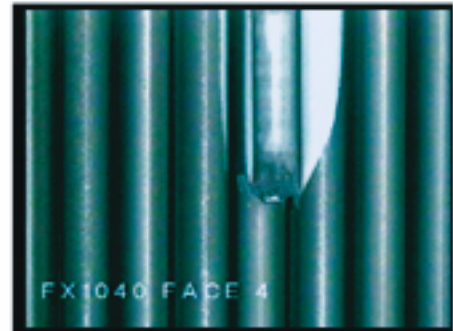
- > 28 failed assemblies (26 second cycle and 2 third cycle fuel assemblies)
- > 56 to 92 failed fuel rods instead of 11 expected → **difficulty in estimating the number of fuel rods failures based on primary coolant activity**
- > all failed assemblies located in an intermediate core ring
- > types of failures : circumferential break (see picture), longitudinal crack, and "sunburst" blister
