Hervé BODINEAU – Thierry SOLLIER – Alexis VERGNAULT – Marc LE CALVAR

Tube support plate clogging up of French PWR steam generators

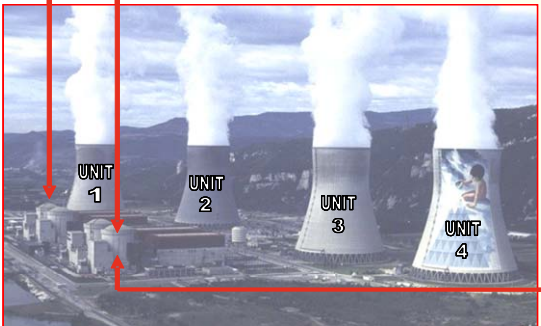
Each leak was detected by N16 channel (Main steam radiation monitor)

- Same S.G. type.
- All the leaks were located at the uppermost TSP (#8).
- All 3 tubes were near the center of the tube bundle near a tube-free area.

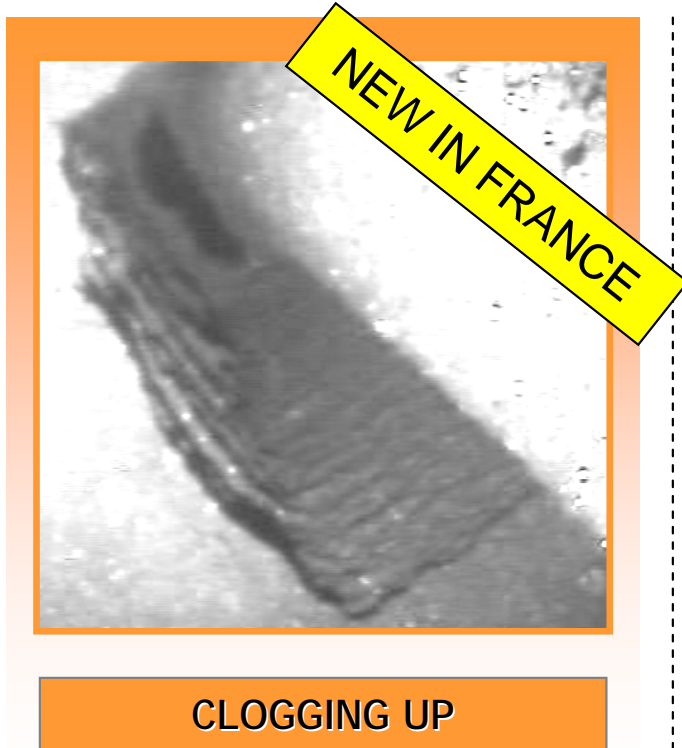
- In the past, the TSP clogging up has never been observed in France.

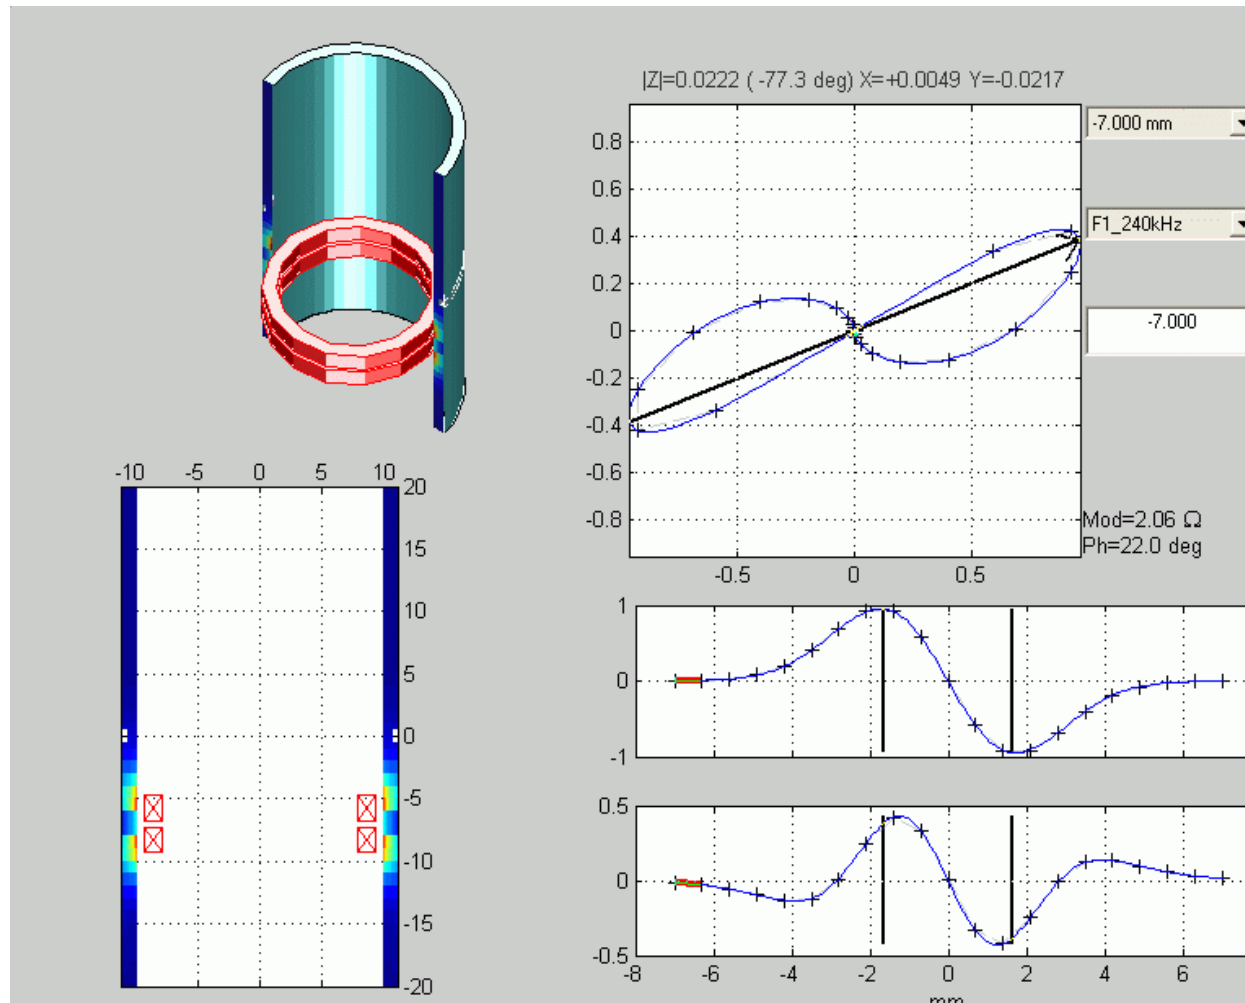
▶ Indirect Means : Eddy Current (bobbin coils), Simulation using CIVA

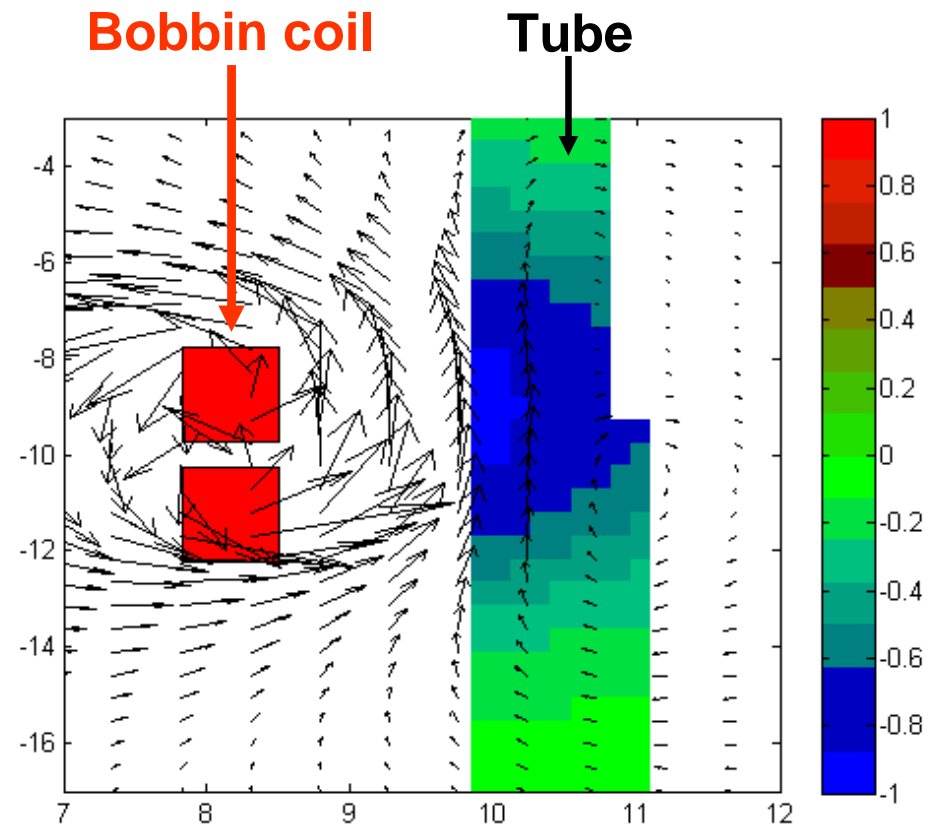
Electromagnetic field and induced currents in the tube

- The bobbin coil produces a sinusoidal electromagnetic field inside the tube wall.
- Currents are induced inside the tube wall and produce an electromagnetic field which is opposed to the incident field.
- A magnetic and/or conductive deposit on the secondary side of the tube modifies the bobbin coil impedance.
This impedance change as the bobbin coil passes the TSPs is used to evaluate the clogging up ratio.

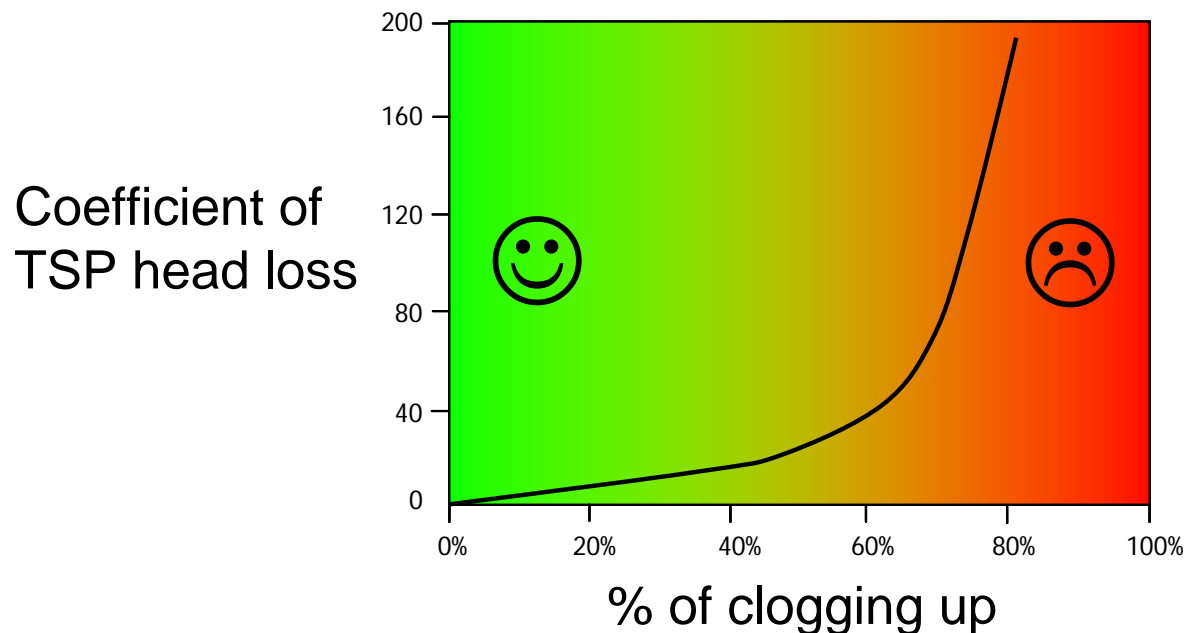
- ① Risk of S.G. tube rupture due to high cycle fatigue.
- ② In case of high clogging up, TSPs and tie-rods could be subjected to heavier loads than considered at the design phase for transients.

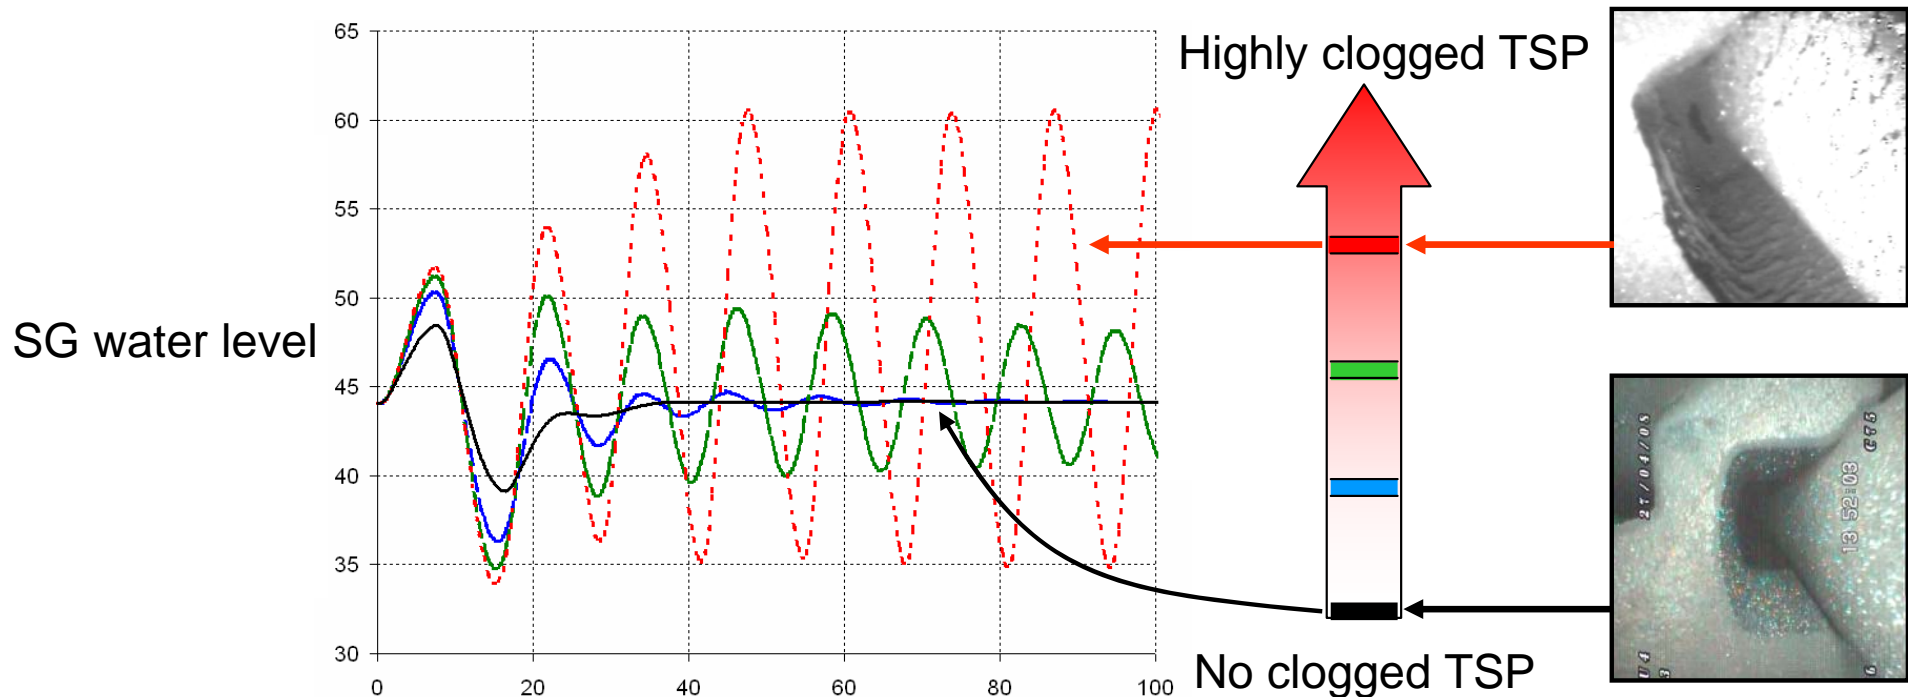
- ③ Decrease of the available water mass for cooling in the secondary part of the SG.
- ④ Instability of the water level in the SG for transients.

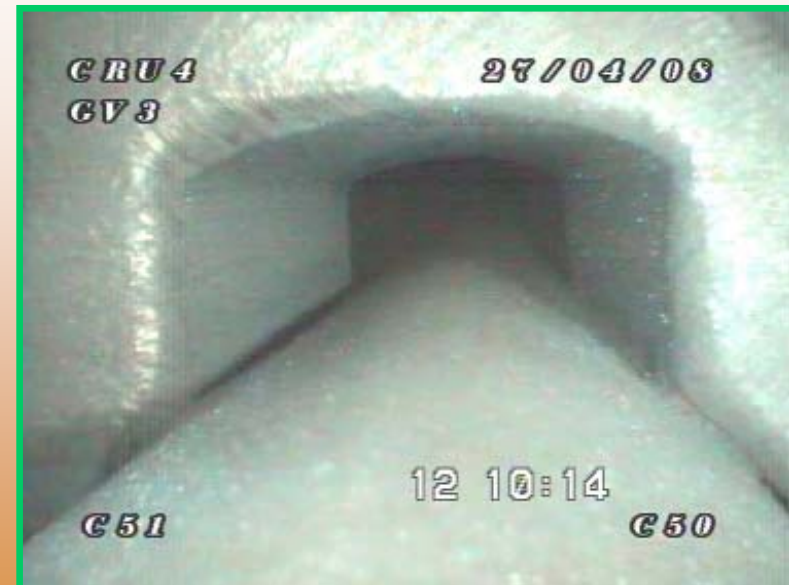
AFTER

**Average clogging up \leq 15%
on the 8th TSP**

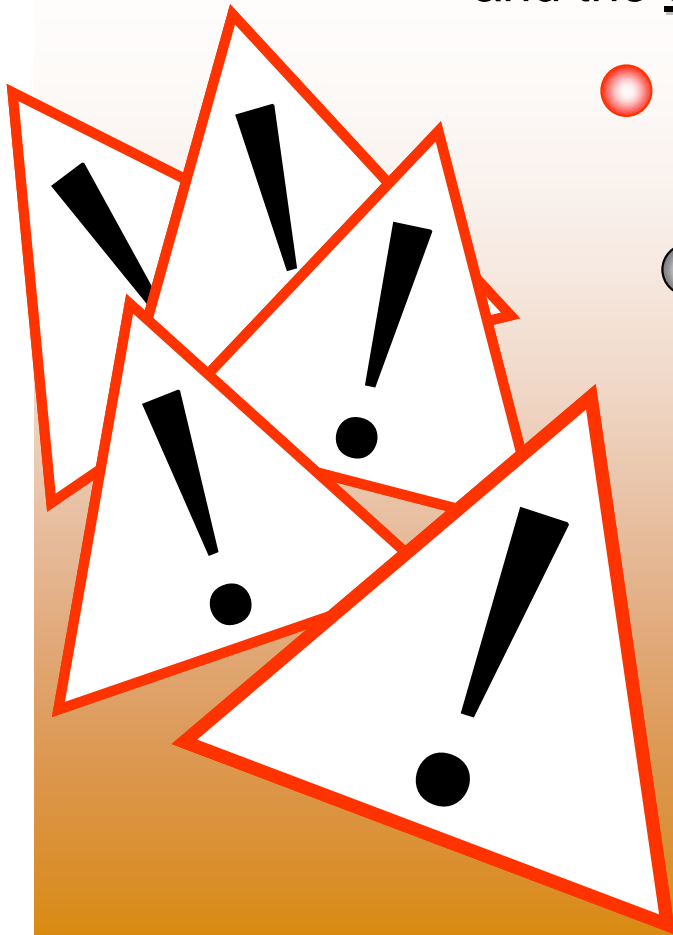
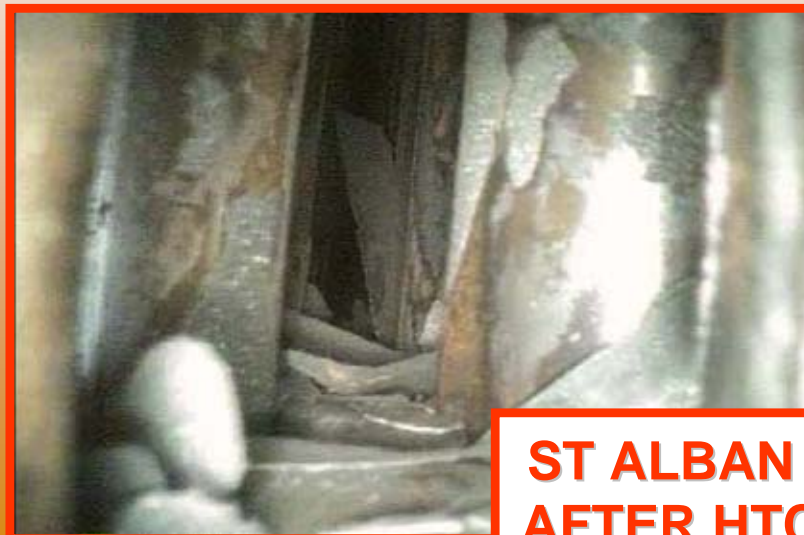
**ST ALBAN 1
AFTER HTCC**

- It has to do **a compromise** between the global **SG corrosion** and the **effectiveness** of the chemical cleaning.
- Very often, there is the **appearance of conductive deposits** (every process, whatever its temperature...)
- The **result** could be **partial** with the HTCC process (For example : Cruas 1 or St Alban 1):

In this case, there is always a drift of the SG wide range level.
