Potential Risk of a Criticality Event During Refuelling

V. Laurieux, P.Deschamps.

Radiological Protection and Nuclear Safety French Institute (IRSN),

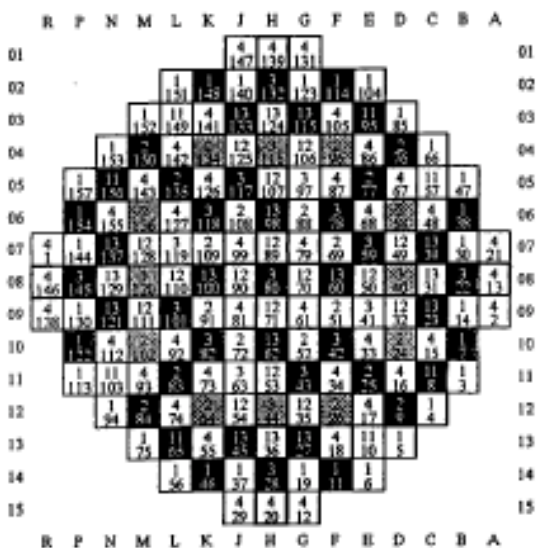
Normal Refuelling

The incident, which occurred on Dampierre Unit 4, is characterised by the fact that 113 fuel assemblies have been misplaced, before the error was detected. Considering this, the consequences of the error in terms of a potential reduction of the margin to criticality during refuelling have been evaluated in order to check if the criticality could have been reached in less favourable conditions (BU = 0 GWj/tU, boron concentration = 2000 ppm) due to the 1st cycle assembly high concentration in the lower left-hand quadrant, and in that case if the detection of its approach would have been efficient.

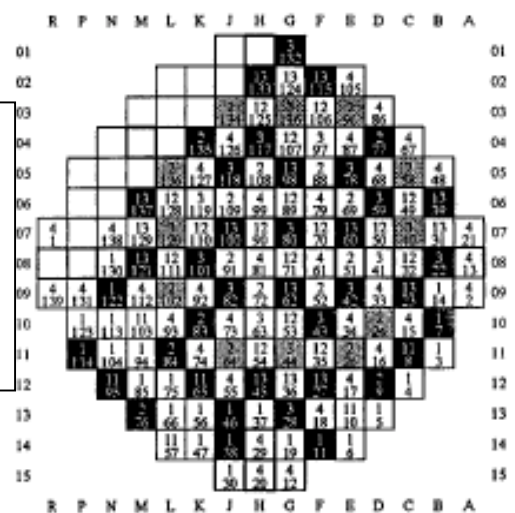
Erroneous Refuelling

The assembly of step n° 25 thus remained in its storage cell in the FB pit.

As shown on the figure below, the step n°25 has been omitted to restore the Dampierre Unit 4 conditions.

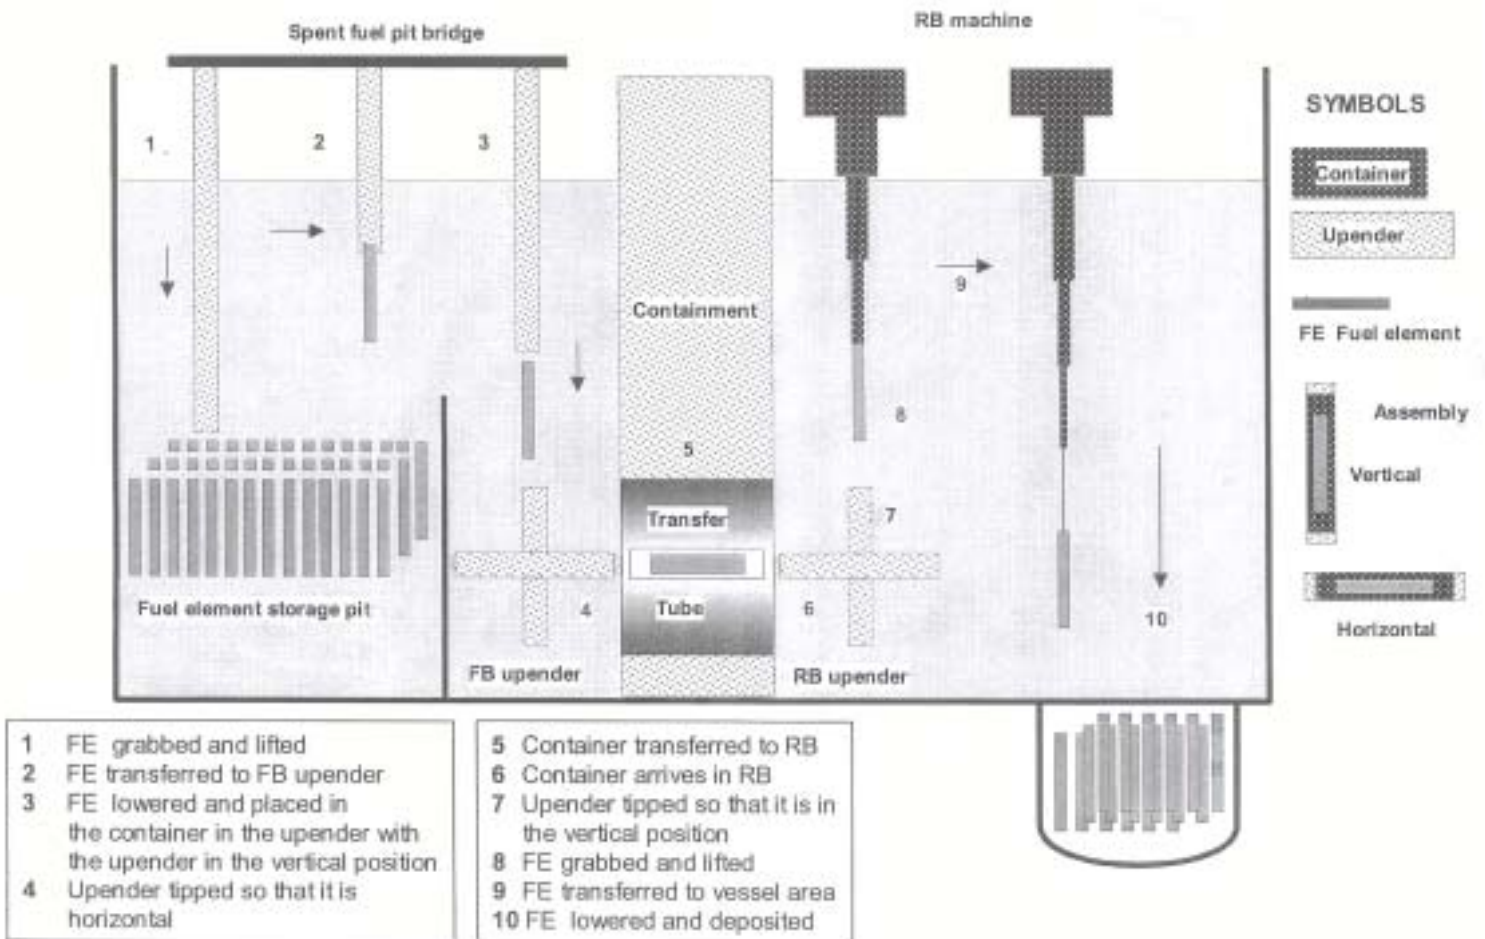
PWR 900 Fuel Handling Detail of a Refuelling Step

The quality assurance for the refuelling is based on the use of detailed operation sheets, one in the FB and one in the RB, identical to each other, corresponding to each step of the refuelling. The checking in the FB of the fuel assembly identification by its own number in accordance with the step operation sheet requirements is the guarantee of an adequate fulfilment of the operations. Fuel assembly identification numbers can be visually checked, in the FB only, by using an underwater camera, and then noted down on the detailed operation sheet. Concerning the RB operations, the refuelling supervisor accepts the assemblies transferred from the FB, following the chronological order of steps listed in his RB operation sheet, without being able to perform any fuel assembly identification numbers. That point reveals a serious lack in the fuel handling process related to refuelling, as no system is available to identify the fuel assembly entering the RB. This aspect has been identified as of major importance in the incident of Dampierre Unit 4 where such a checking would have allowed to prevent from the omission of one step.
